FINAL REPORT

Fall Mission: October 26, 2010 – December 21, 2010

“Conservation and Documentation of the Wall Paintings at the Red Monastery, Sohag”

Sub-grant No. EAC-28-2010

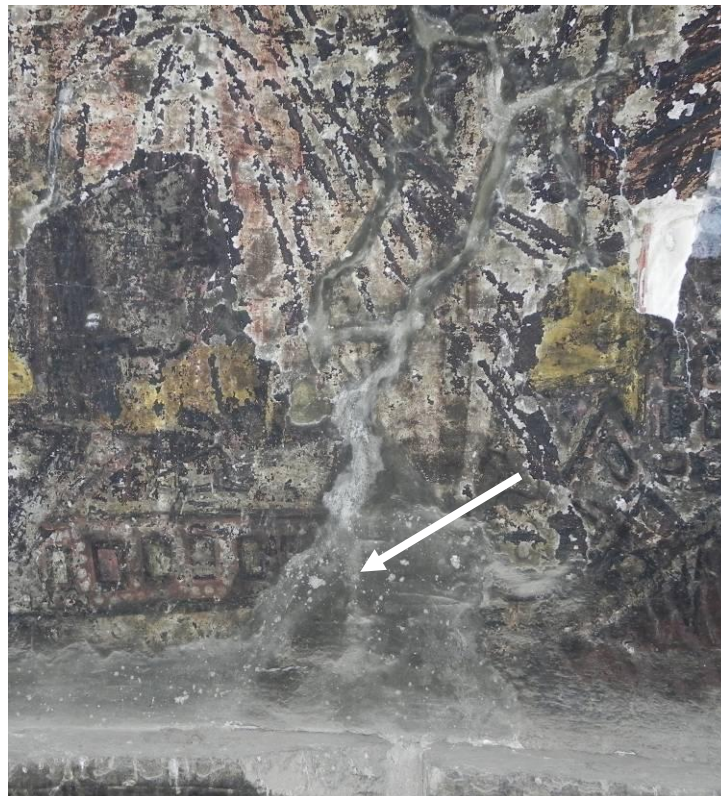
Figure 35

Other equally obvious and grave effects of these structural problems include the presence of slightly misaligned planes and a series of cracks running vertically in the semi-dome. The misalignment of planes can be seen along the line dividing the area beneath the arch from the apse and impacts severely on the masonry and plaster. The problem is exacerbated because the masonry changes from blocks of limestone to red bricks at this point.

Most of the falls of plaster can be seen to have occurred along the line of these cracks (Figure 35).

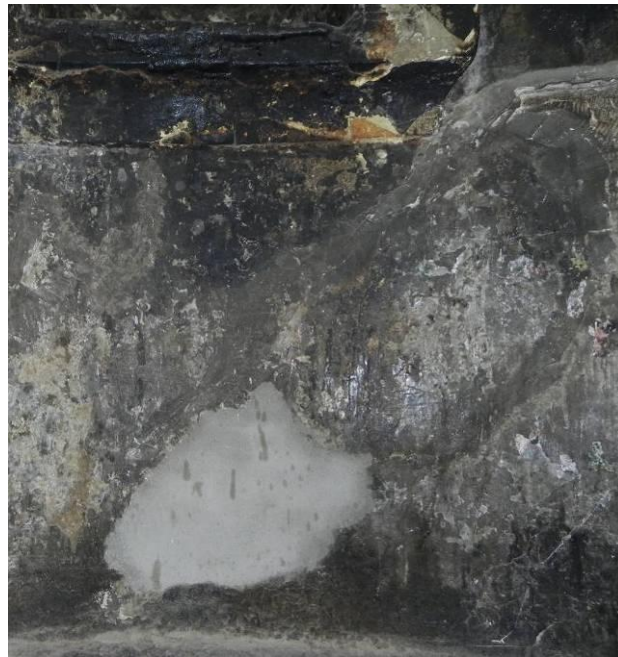
Figure 36

The floors of the niches are used as shelves and have been exposed over the centuries to an accretion of burnt material from candles and oil lamps that has caused severe damage to the stonework in the central and right-hand niches. In the central niche the floor has been covered with a slab of white marble approximately 3 cm thick owing to the degree of damage and parts of the plinth of the small south column are missing. In the right-hand niche, the original slab is missing and a new floor has been created at a lower level using a cement-based mortar. Approximately two thirds of the bracket has also been lost. In the north niche opposite, the limestone floor has been repaired with a cement-based mortar. There are gaps in the plaster (Figure 36) in the lower area between the columns where the large *velarium* is painted. A deep crack running vertically through the entire lobe terminates on the right of the south-east column. The crack has caused the plaster to fall off or become raised in places, some of which have been repaired with cement-based mortar that encroaches extensively on the original surfaces.

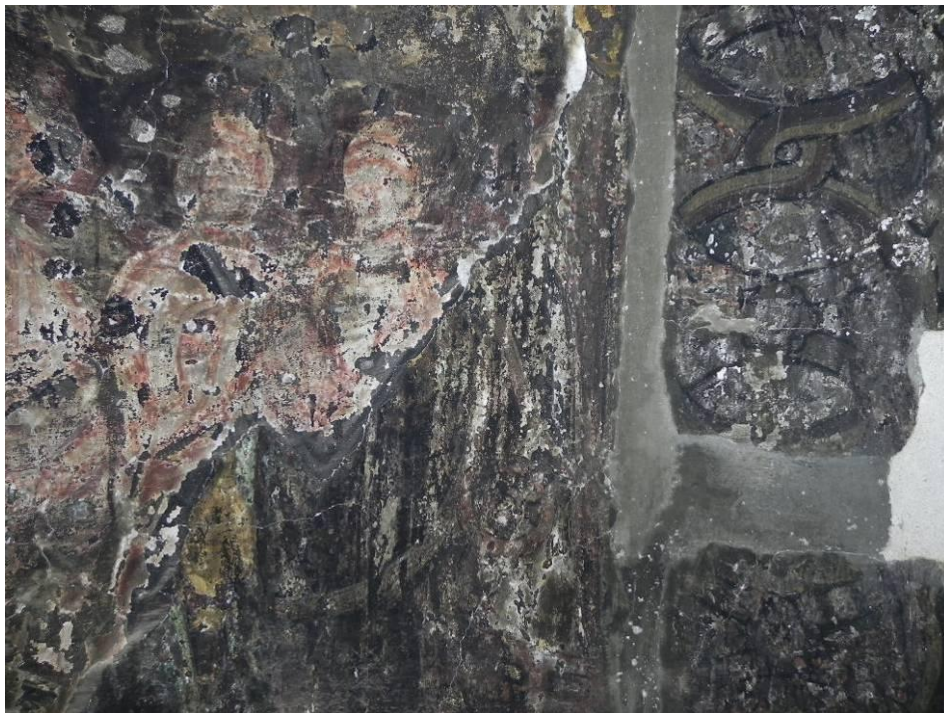
Figure 37

Today, phase two is primarily visible in the preparatory drawing. This state of affairs can be attributed principally to the fact that the detachment and loss of the third-phase plaster tore off and destroyed the painted finish of the second¹¹.

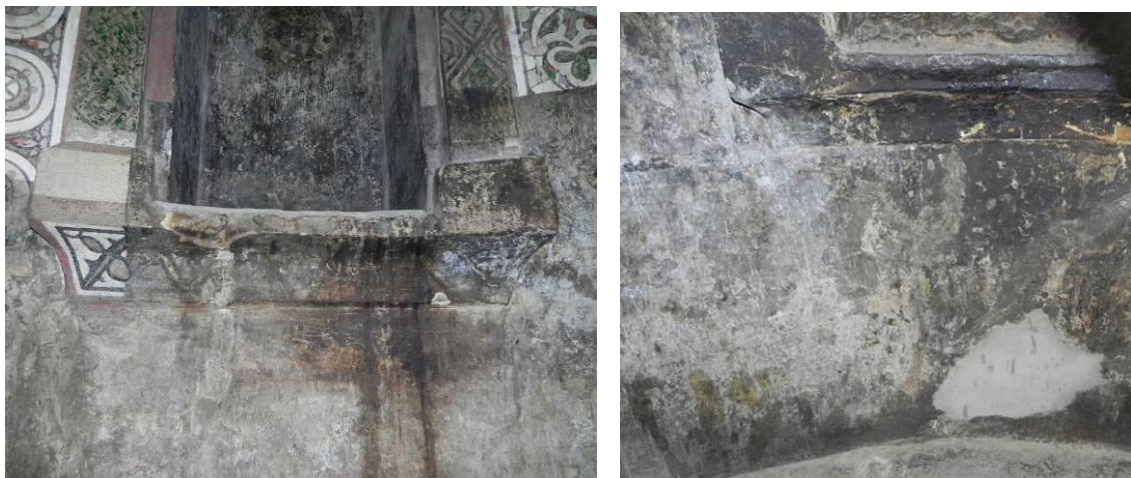
Figures 38 and 39

There are numerous drips of candle wax under the brackets of the niches and many of the original details are covered by traces of pointing used in repairs. Furthermore, damage to the paint layer has increased as a result of human activity owing to the repeated and more intensive use of the area, particularly since the altar was moved to the inside of the lobe.

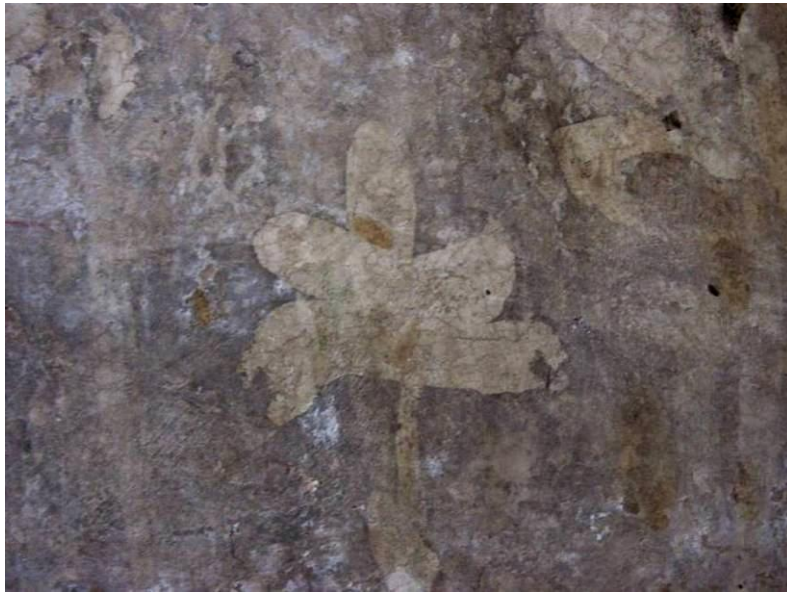
Figure 40

The details painted using the encaustic technique have been partially lost. When they fell, these details left imprints that can be distinguished by their lighter color from the general level of dirt. These imprints are extremely important to us as they testify directly to the working method and, in particular situations where the damage is serious, become essential elements for the preservation of painted motifs that would otherwise be lost (Figure 40).

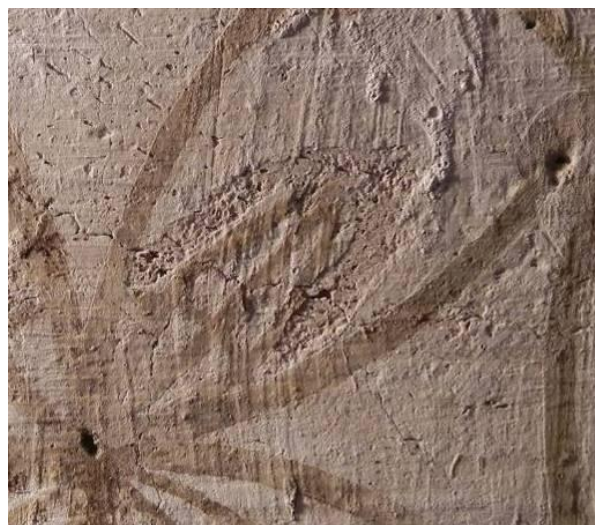
Figure 41

The composition of the painted cross enables us to read a good many of the iconographic details. The painting was exposed to atmospheric agents for a long time and its finish has been extensively abraded and thinned by exposure to the wind that often carries desert sand. Exposure to the rays of the sun has caused the loss of those details painted using the encaustic technique. High temperatures have also caused an unusual type of damage: the details painted with wax contracted before they fell off, tearing the finish of the plaster and leaving imprints slightly below the rest of the surface (Figure 41).

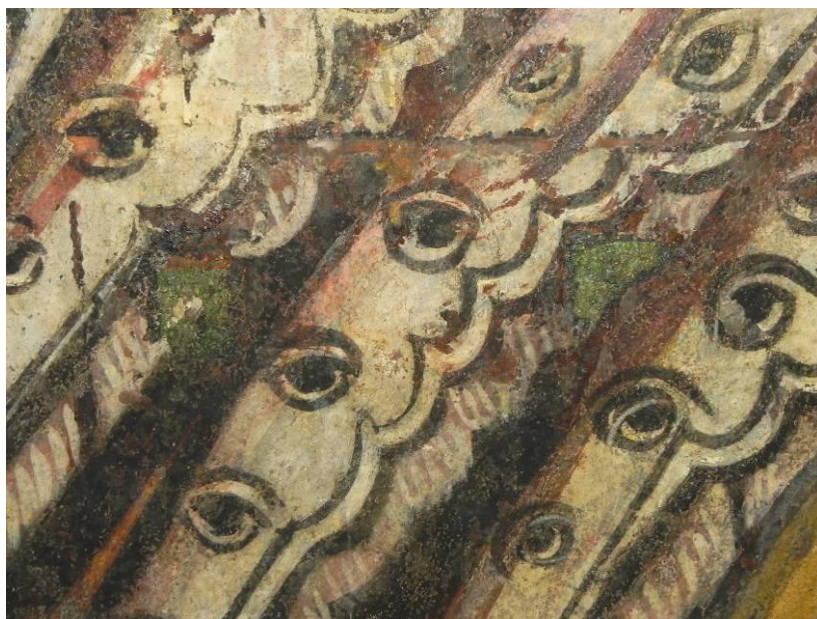
Figure 47

The black lines around figures and decorative elements traditionally added as a finishing touch to the painting process were particularly fragile in some instances (Figure 47). As a result, after preliminary cleaning, some of them had to be fixed with acrylic resin (15% PARALOID B72 in a nitro thinner) applied with a brush. Once the cleaning operation was completed, the fixing was removed with organic solvents applied through Japanese paper.
